COLLINS S-LINE/KWM2 DIAL ASSEMBLIES - Part 1

by Ed Brooks, W5HTW ed.brooks@worldnet.att.net

COLLINS S-LINE/KWM2 DIAL ASSEMBLIES

Collins Legacies: 32A And 32B Transmitters

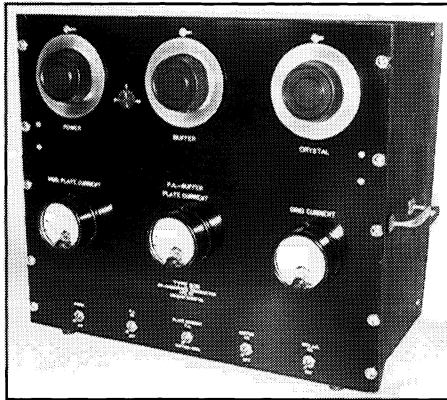
Front view of J.B.'s recently restored 32B

The Collins 32A CW Transmitter and its radiophone companion, the 32B, were designed to exploit fully the possibilities of the new type 46 tubes. These transmitters followed the general circuit arrangement laid down by George Grammer in the July, 1932, and subsequent issues of QST, although the constructional features were modified to conform to Collins' standard constructional methods. These transmitters are very similar in appearance and construction to other Collins transmitters, such as the 30W and 40B.

The Radio Frequency section employs a type 47 crystal oscillator, 46 buffer, and two 46 power amplifiers in the final modulated stage. The speech amplifier and modulator uses a type 57 audio gain, 46 driver and two 46's in push-pull as class "B" modulators.

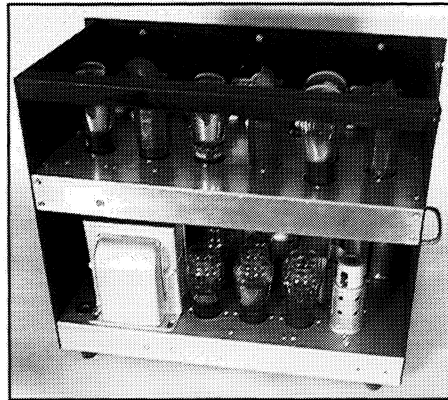
Back view of J.B.'s recently restored 32B

There are two complete power supplies in this transmitter; one is using an 80 rectifier and the other is an 83 mercury vapor rectifier, operating on 110-120 volts, 50 or 60 cycle A.C. current.

Three surface type high grade milliammeters are furnished for reading plate and grid currents in the various stages. One of the primary specifications set that was forth for the design of every Collins transmitter is that it must be capable of tuning solely by meter readings and that no flashlight bulbs resonance indicators or other "gadgets" are required to adjust it properly on any desired frequency.
